## Infrared Images with Blower Door running provides air leakage paths and insulation performance issues

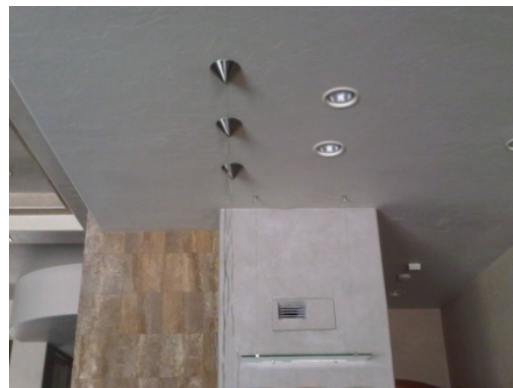
Leaking ceiling light penetrations & varying insulation performance  
Wall: Leaky top plates

After air sealing lights and top plates, blow cellulose insulation without voids, gaps or compression over all IC rated light fixtures.

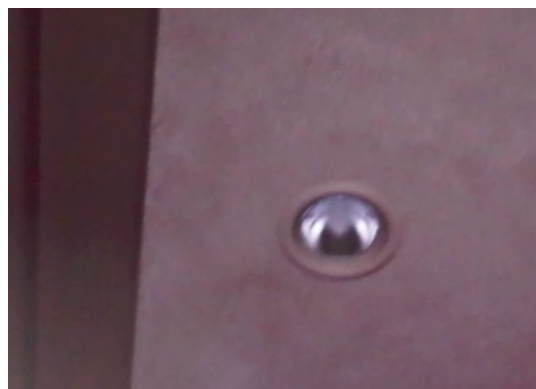
Leaky recessed lights allow extreme temperatures and dirty air from the attic to enter house.

After air sealing lights, blow cellulose insulation without voids, gaps or compression over all IC rated light fixtures.

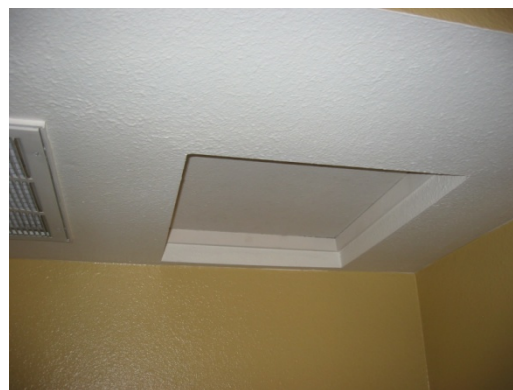
Leaky and uninsulated attic accesses are a direct route for extreme attic temperatures & dirty air to enter home c access.

Air seal and insulate attic or install Battic's EZ Attic Access.

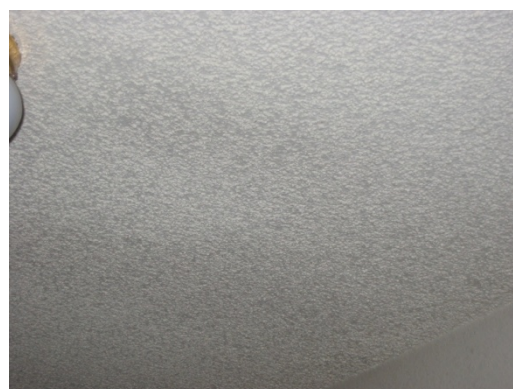
Extreme temperature attic air heating the home (summer) because of missing or poorly installed vent baffles and insulation.

*Note: The wood studs are cooler (more blue) than the wall cavities.*

Foam seal top plates & frieze-blocks, install baffles to prevent wind washing (blowing insulation) and insulate with blown cellulose.

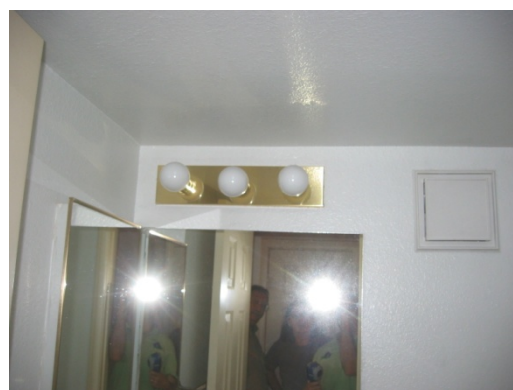
Extreme attic air temperatures heating the home (summer) because of leaky top plates and Junction Box behind light fixture.

Seal top plates & junction box and insulate with blown cellulose.

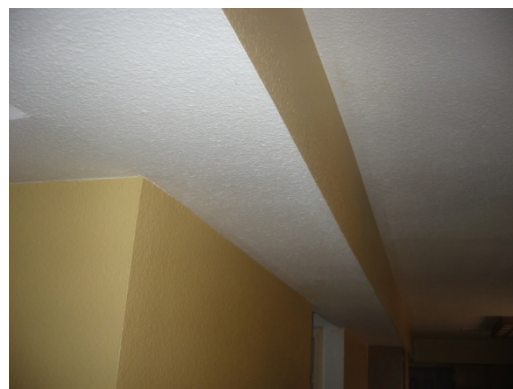
Extreme temperature attic air heating the home (summer) because of leaky top plates and missing or poorly installed insulation.

Foam seal top plates and fill soffit and cover top plates with blown cellulose insulation.
